# REMEDIAL LINING REPAIRS DUKE POINT WATERMAIN GREATER NANAIMO WATER DISTRICT

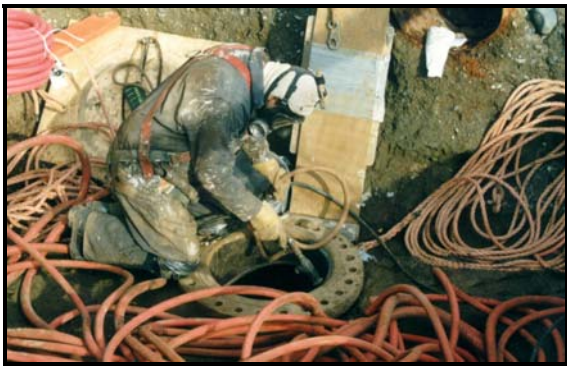
*Preparing the pipe interior with abrasive blasting prior to the application of the coating material*

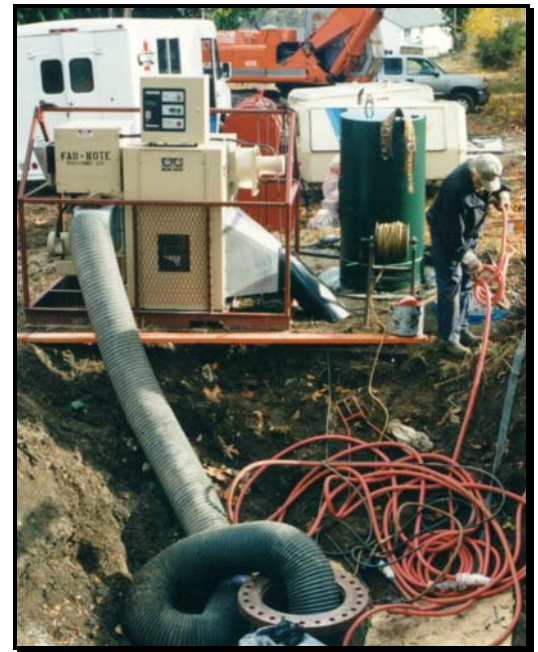
*Dehumidification equipment used to cure the applied coating material*
